**Independence Court Streambank Stabilization  
Feasibility Study**  
Prepared for the City of Leavenworth  
Feb. 00, 2019

Subject: Independence Court Streambank Stabilization Feasibility Study report

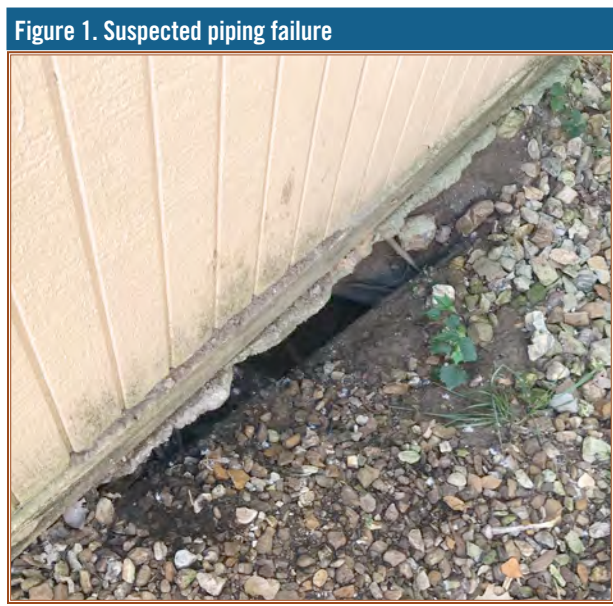
Figure 1. Suspected piping failure

WRS Principal Don Baker, PE, visited the residence at 1421 Independence Court on Aug. 9, 2018, where he briefly interviewed owner Geneva Pressley. Baker observed holes and areas of settling appearing under and near a shed in the backyard. He concluded the

holes were likely piping failures, a progressive development of internal soil erosion caused by backward erosion from the stream upward into the bank, until a continuous “pipe” is formed between the upstream area and the stream. Such continuous pipes are associated with bank failures. It was during this interview that Pressley also expressed her belief that the creek had moved closer to her yard in the years since she had first moved into the residence, and that recently the stream seemed to be eroding at a faster pace. Baker further confirmed that the neighboring residence to the west of Pressley’s is experiencing similar levels of erosion and bank failure.

A suspected piping failure associated with bank failure under the shed in the backyard of 1421 Independence Court.

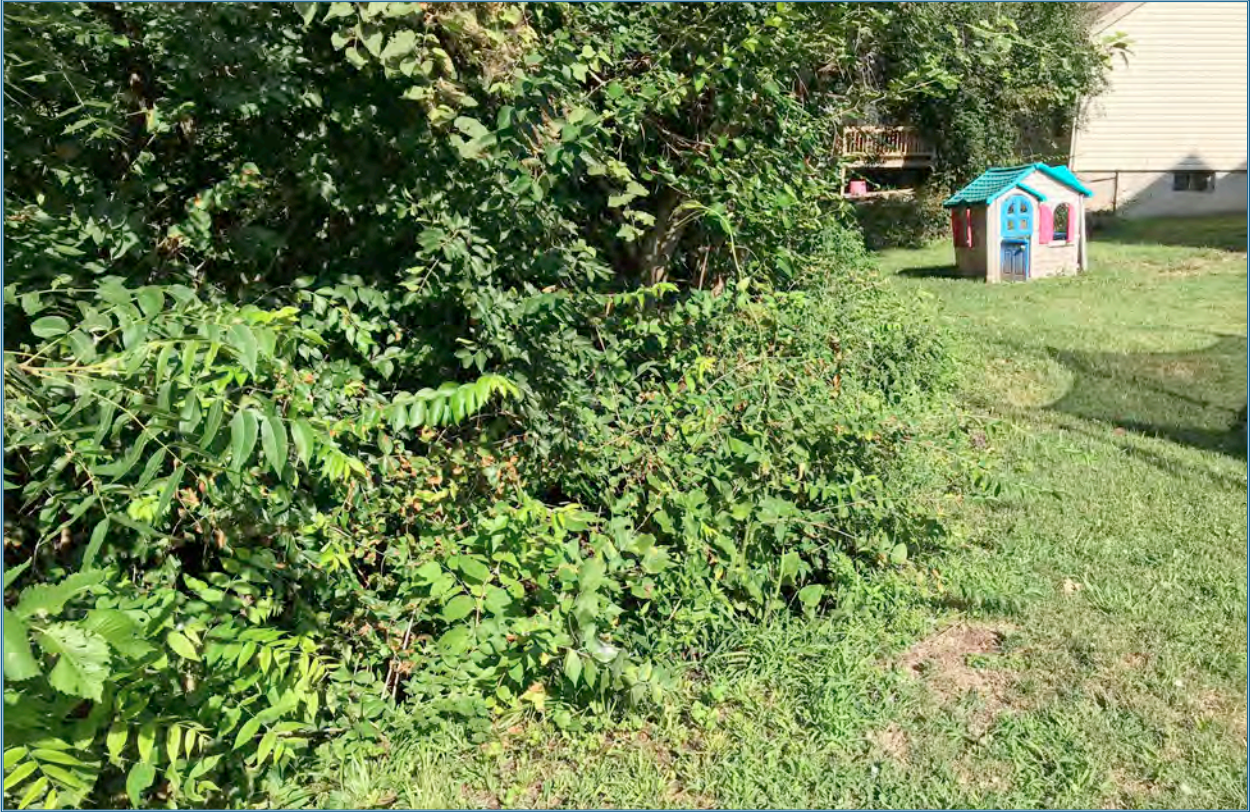
Figure 3. Meander encroaching on residential yard

time indicates the stream is lengthening to accommodate the additional flow, and it is that change in meander that accounts for the movement of the stream into the threatened residential yards. Additionally, the added flow has lowered, or incised, and widened the stream bed, in an attempt to reach equilibrium under the additional flow.

The residential backyard being threatened by the changing meander of the tributary.

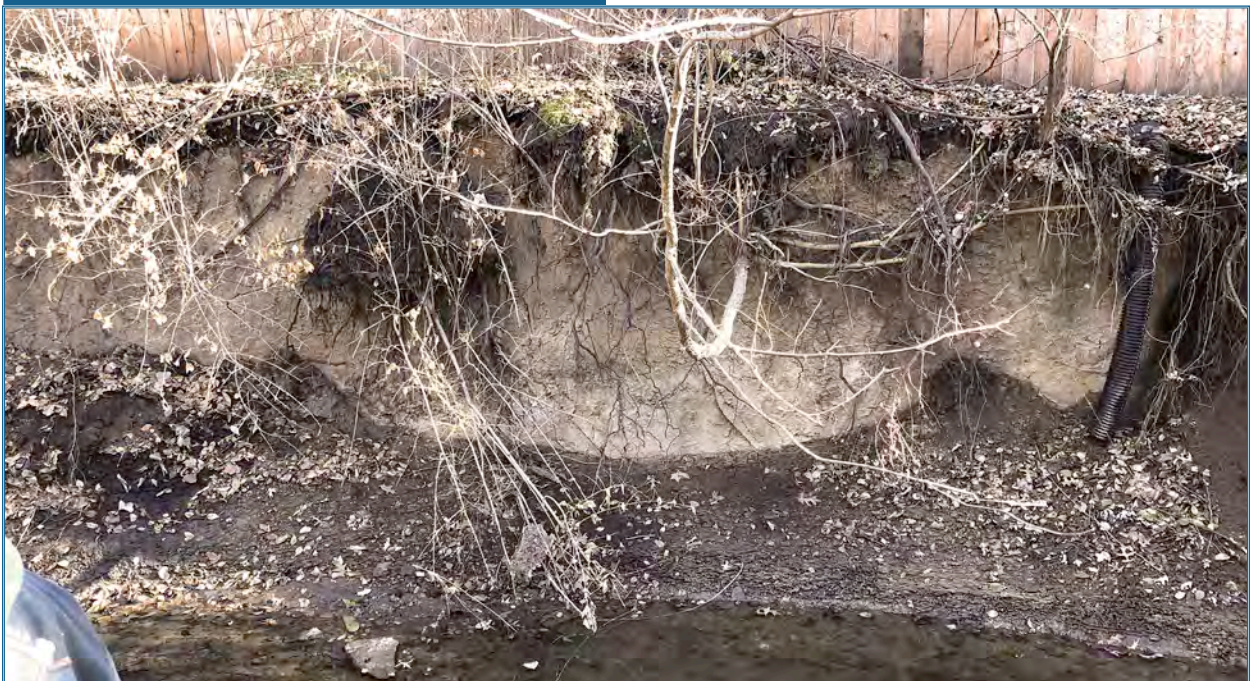
Figure 4. Bank undercutting and slope failure

Severity of bank undercutting and slope failure adjacent to 1421 Independence Court.

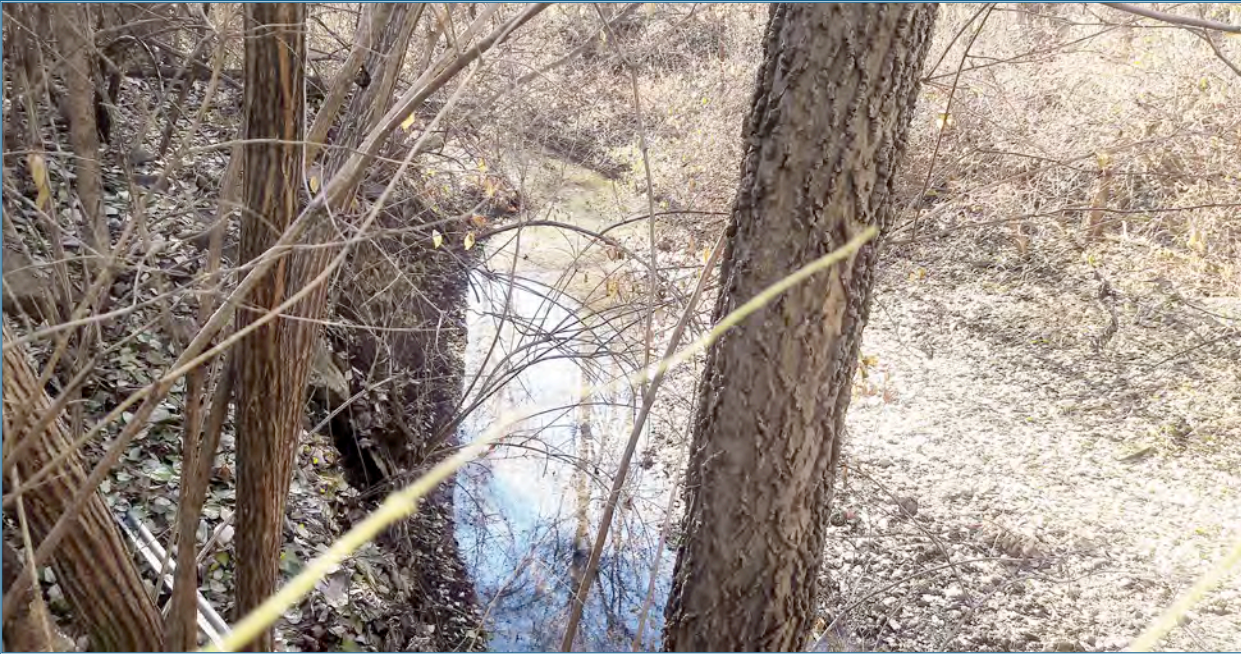
**Figure 5. Stream meander near project area start**

Example of stream meander near the start of the project area. The bank on the left side of the photograph is vertical and approximately 15 feet high.

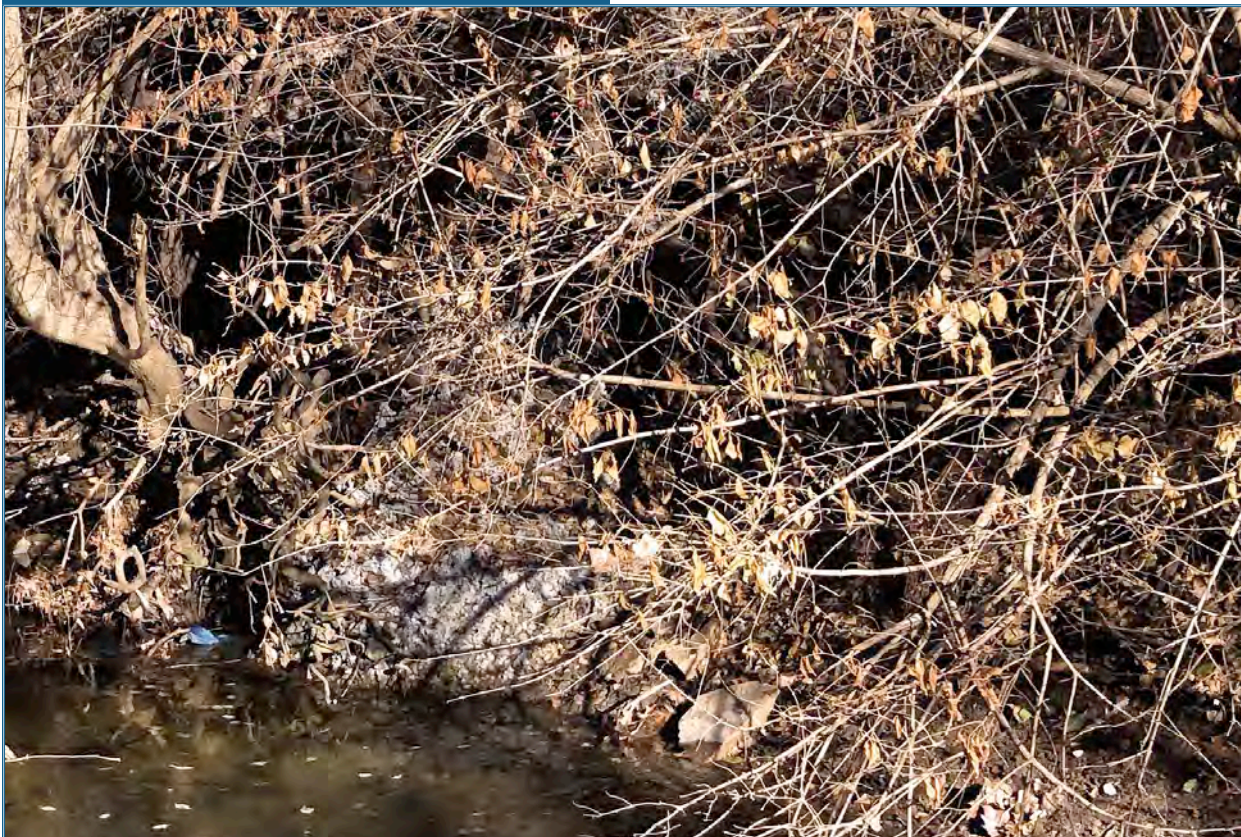
**Figure 6. Failed repair attempt by property owner**

Concrete slurry poured by property owner into bank hole. The concrete slurry went through the hole and into the stream.

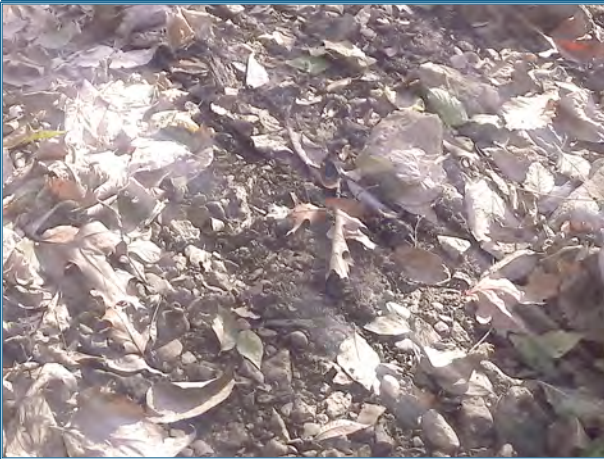
Figure 9. Rock in stream bottom in Reach 1

Rock in the stream bottom (Figure 9) helps armor the channel in Reach 1. Debris in the RCP at Thornton (Figure 10) has choked the space to about 43%.

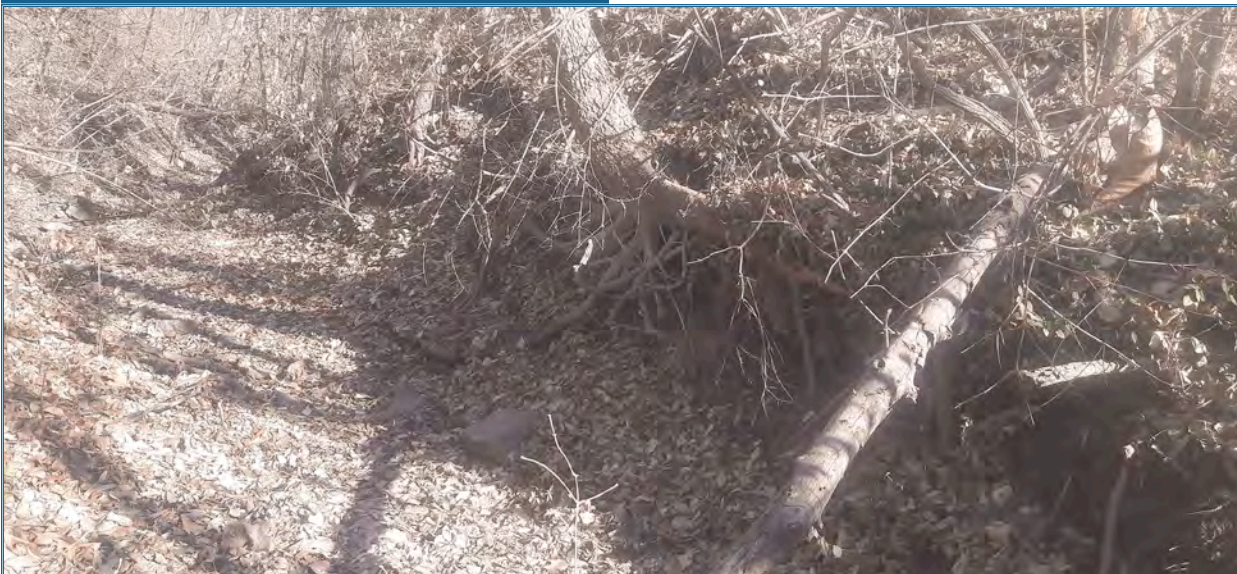
Figure 11. Evidence of mass wasting in Reach 1

Some evidence of stream instability in Reach 1 includes mass bank wasting (Figure 11).

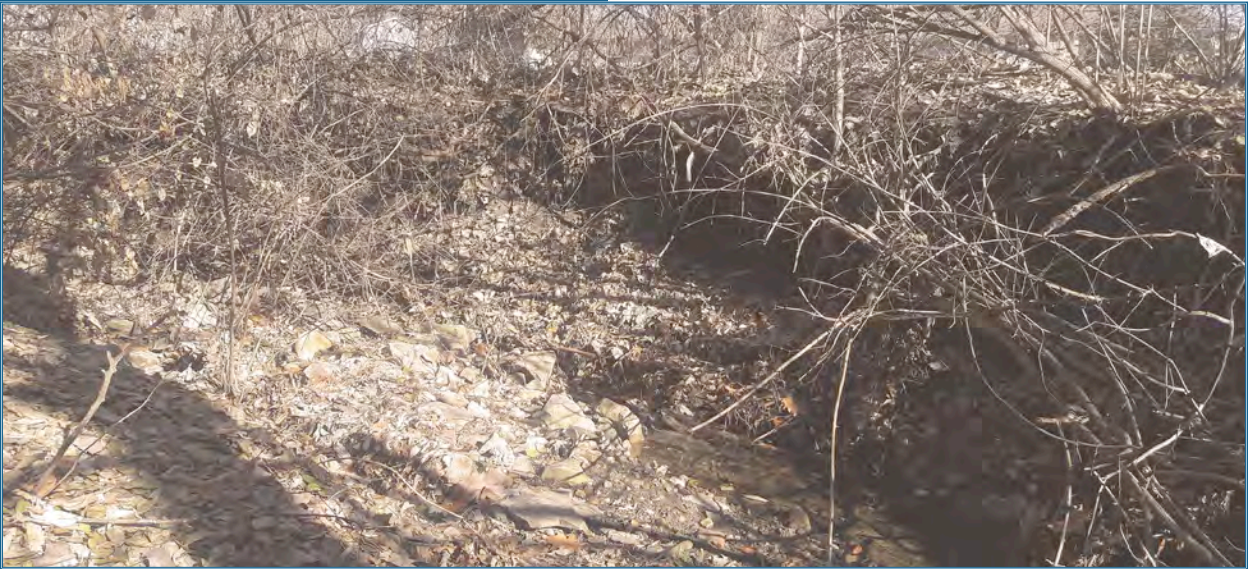
Figure 12. Vertical cut bank in Reach 2

Vertical cut bank and mass wasting (Figure 12) indicates stream instability in Reach 2.

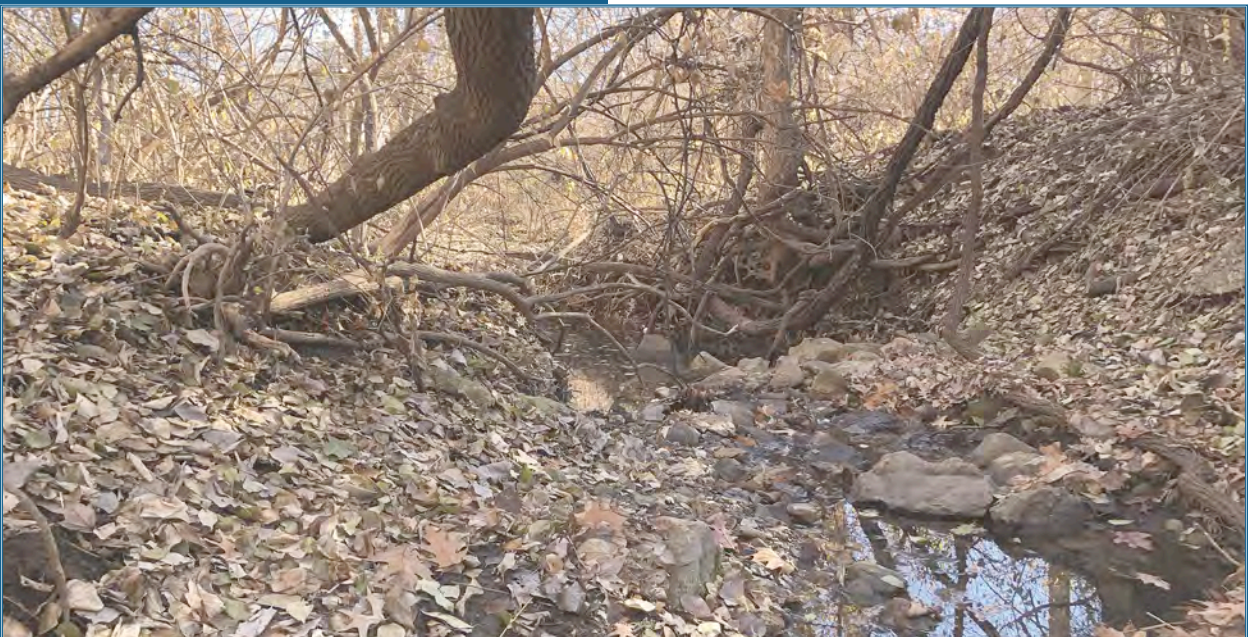
Figure 13. Displaced rock revetment, Reach 2

ing of stone meant to protect the bank placed in the channel downstream of existing storm sewer outlets, has moved. Scour is present at the ends of these systems. Trees are falling into the channel, causing constrictions and possibly serving as a source of debris. The straightening of the stream resulted in an increased slope which created the velocity and shear stress conditions for increased scour.

Rock revetment placed in the stream (Figure 13) to protect the bank has moved, leading to scour downstream.

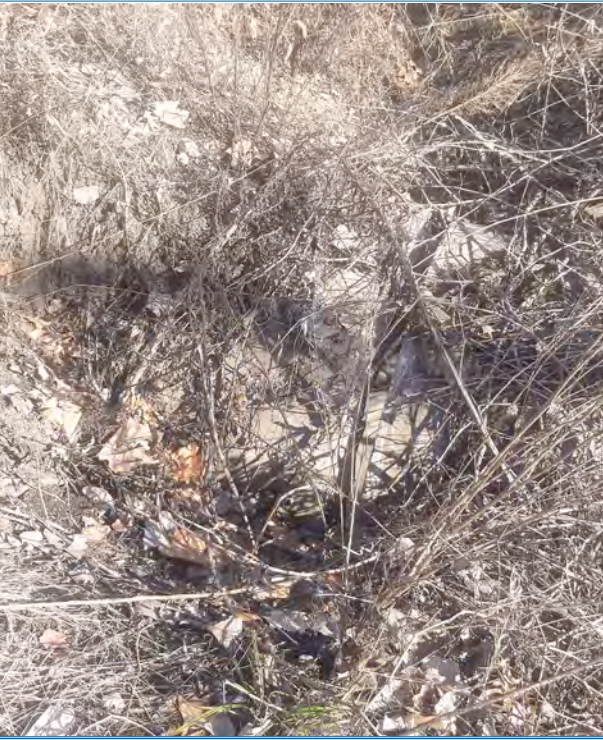
**Figure 14. Separated 60-inch RCP end, Reach 3**

Instability indicators in Reach 3 include separation in a 60-inch RCP due to scour (Figure 14), mass bank wasting (Figure 15), and bank scouring (Figure 16).

Consideration should be given to those reaches where property and infrastructure may be at risk because of stream instability. Additionally, it is recommended the city clean the 48-inch RCP north of Thornton and repair the 60-inch outlet south of Evergreen.

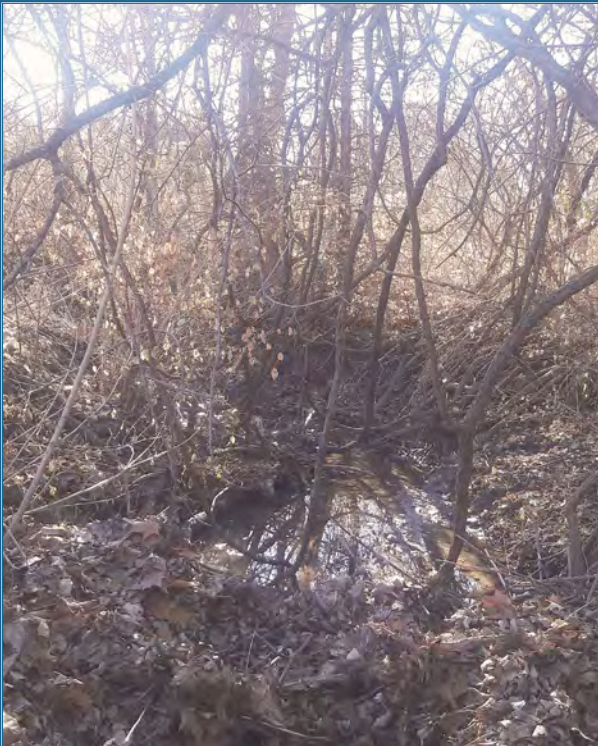
**Figure 17. Debris at Vilas Street, Reach 4**

Despite offering more room in its floodplain for the stream to move, Reach 4 demonstrates some potential instability, including debris load (Figure 17) and concrete revetment (Figure 18).

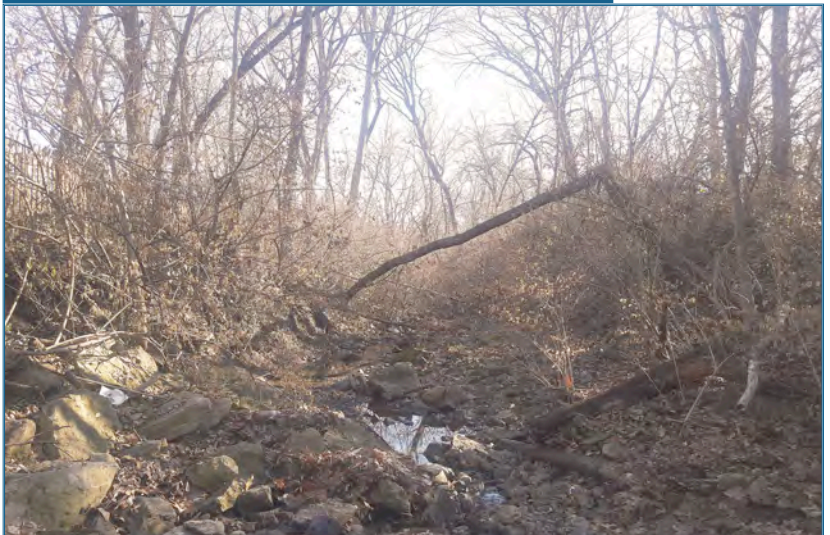
**Figure 19. Trees falling into channel, Reach 5**

Rock armors the stream channel bottom in Reach 5, leading to stream widening and erosion, threatening trees along the bank (Figure 19).

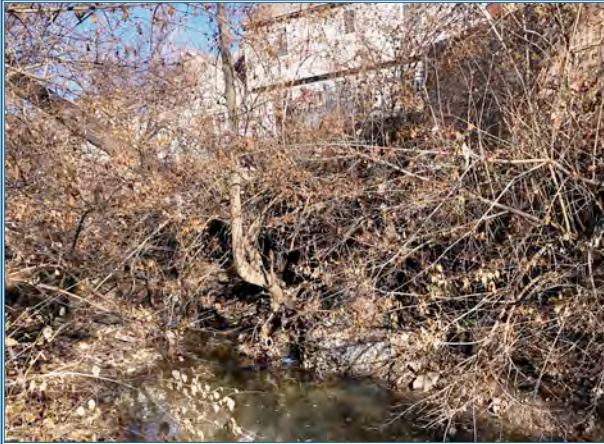
**Figure 20. Cut bank behind residences, Reach 6**

Extensive mass bank wasting in Reach 6 includes a 15-foot cut bank behind 1421 Independence Court (Figure 20), bank slide failure (Figures 21 and 23), and piping failure in the yard at 1421 Independence Court (Figure 22).

In Reach 6 the channel degradation needs intervention to protect private property and city infrastructure. In order to protect the at-risk property, option 1 is the recommended alternative. Although option 2 would provide a more holistic approach, option 1 is a more targeted solution that would provide a complete solution to the project problem, at a cost of 41.5 percent of option 2.
