## PHASE I ENVIRONMENTAL SITE ASSESSMENT

**Price Chopper Property  
2107 South 4th Street  
Leavenworth, Leavenworth County, Kansas**

EWI Project # 9068

September 09, 2019

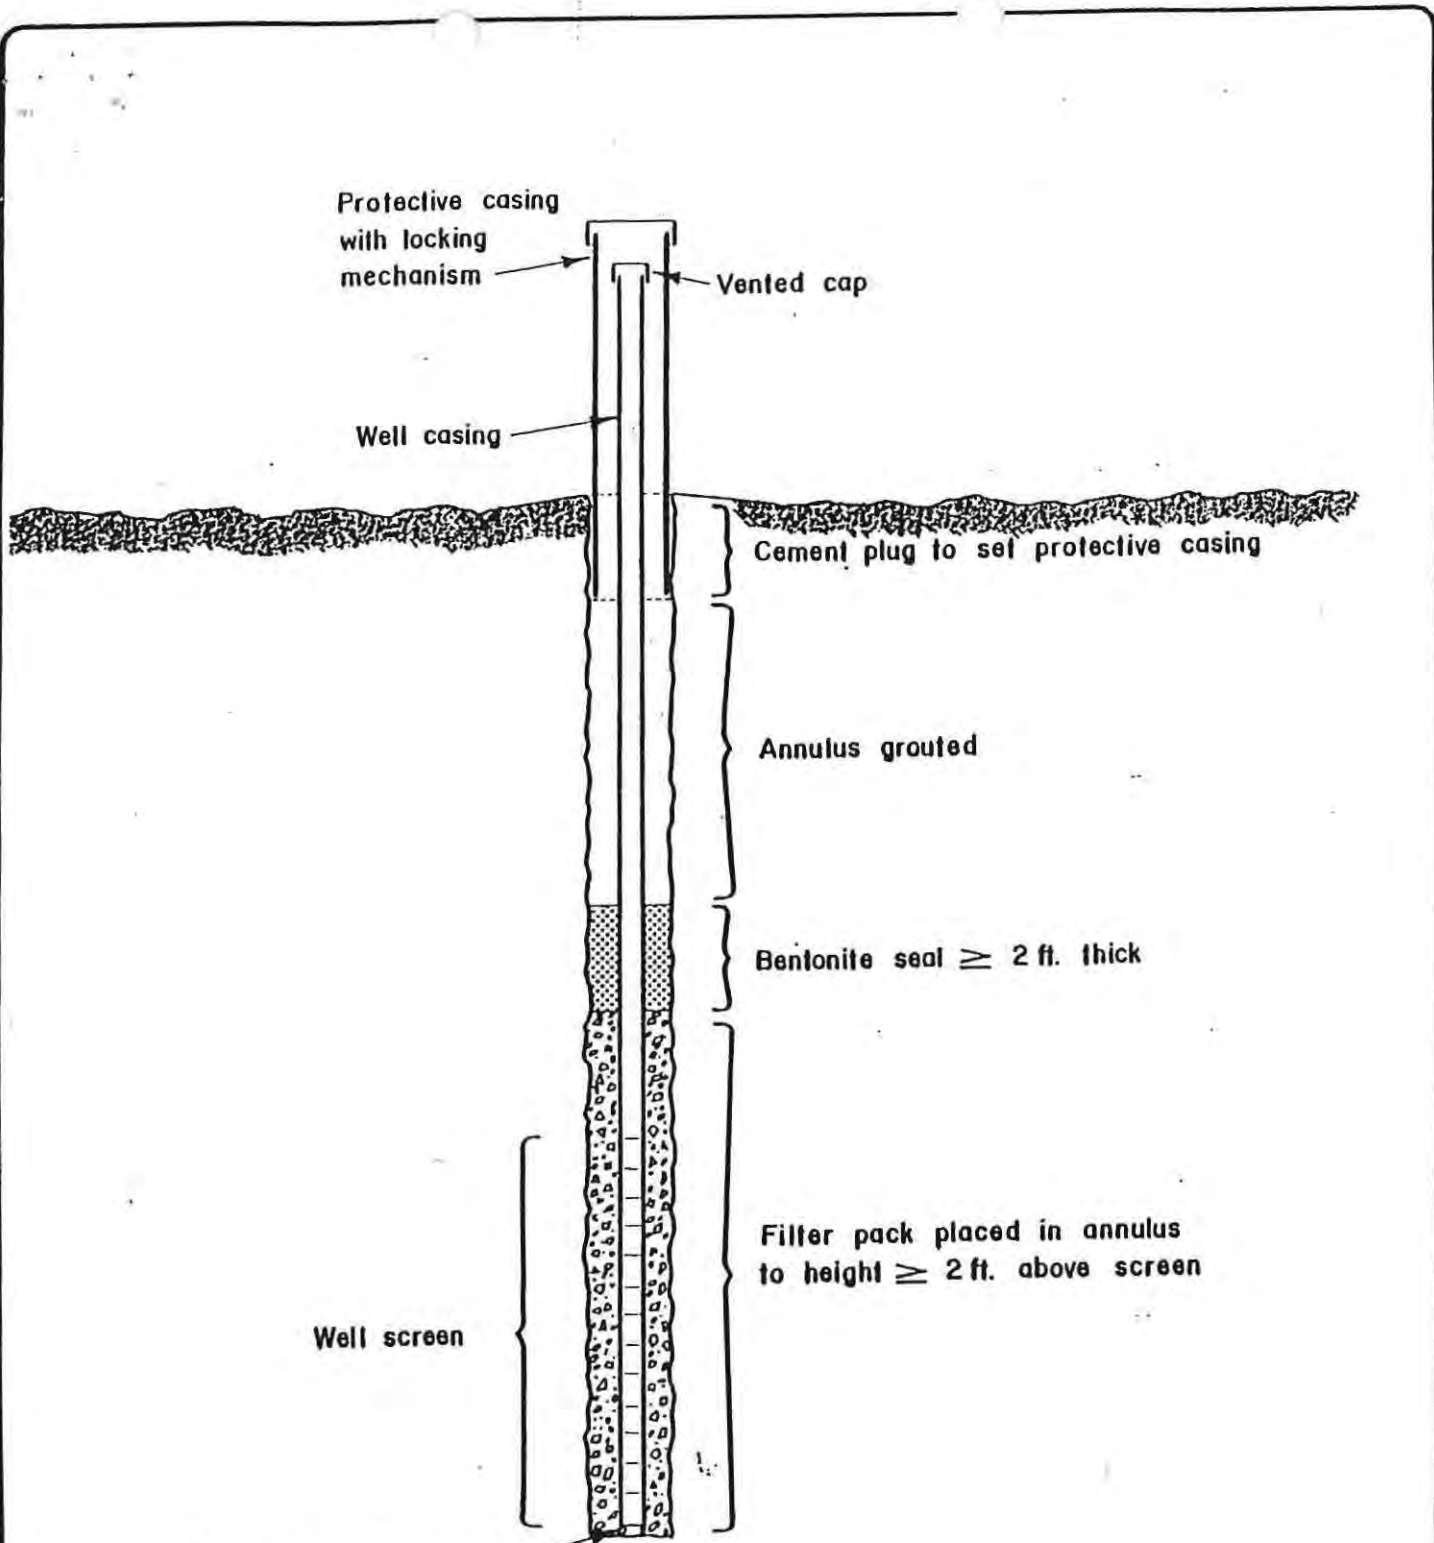
**Monitor Well Design**

Protective casing  
with locking  
mechanism

Vented cap

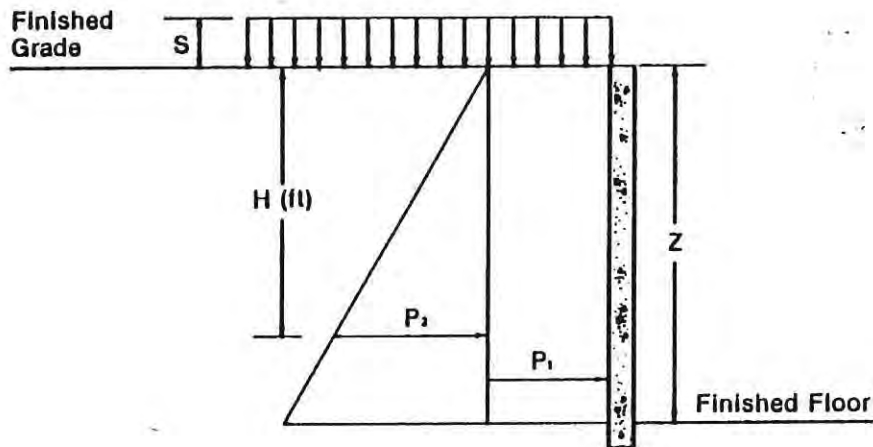
# AT-REST EARTH PRESSURE ON 1-FOOT WIDE VERTICAL STRIP (NO WALL ROTATION)

- $S$  = Uniform surcharge at grade, load in psf  
 $Z$  = Wall Height (ft)  
 $P_1 = 0.45 S$  = Effect of uniform surface surcharge  
 $P_2 = 50 H$  = Earth pressure

- Coefficient of at-rest earth pressure = 0.42
  - Units of  $P_1$ ,  $P_2$  in psf
  - Horizontal Backfill
  - Wall Backfill compacted to 95 percent of Standard Proctor maximum dry density
  - In-situ soil weight
  - No safety factor included
- Uniform surcharge
  - Negligible wall friction
  - No ground water acting on wall
  - Loading from heavy compaction equipment not included
  - No wall rotation

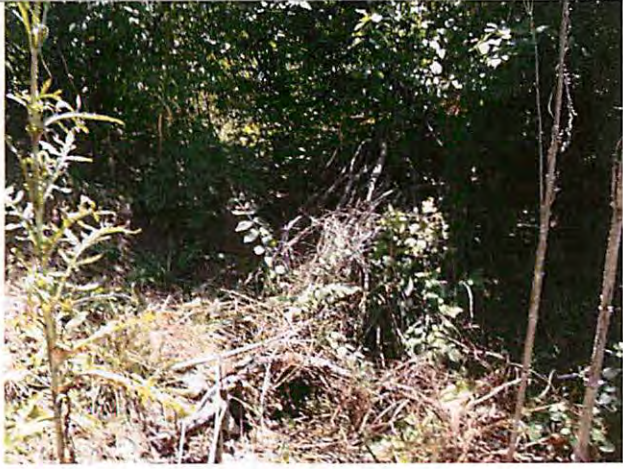
Photo Taken: 8/14/2018 4:23:16 PM	Near the NW corner of the site. Appears as if the city dumps spoilage from city projects here. Site is heavily overgrown.

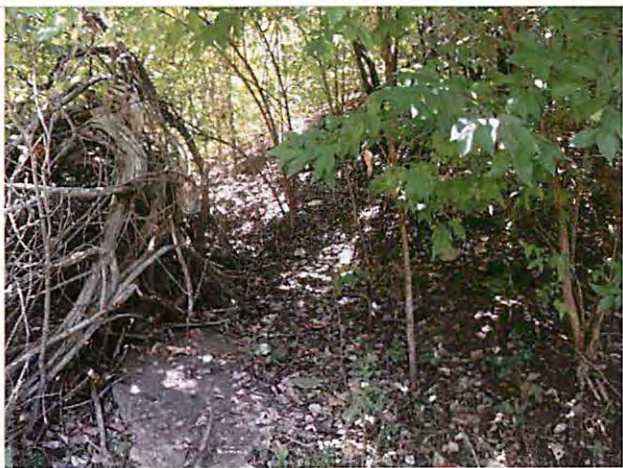
Photo Taken: 8/15/2018 8:39:37 AM	Walking south into the area about ten yards. Piles of soils are evident that have been dumped several years ago judging by the size of the small trees.

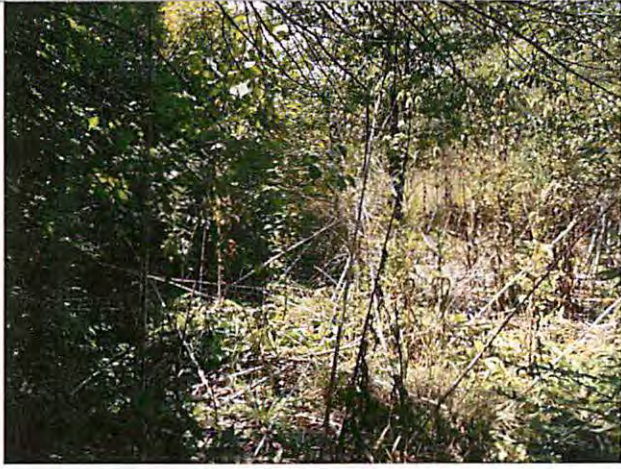
Photo Taken: 8/15/2018 8:48:10 AM  Approximately the center of the site. There are no visible wastes.	
 	Photo Taken: 8/15/2018 8:49:23 AM  The Cities WWTP is just to the north of the site.	
 	Photo Taken: 8/15/2018 8:50:17 AM  Along the west side of the site.	
31a. If the photographer is different than the inspector completing the report, list there name here.

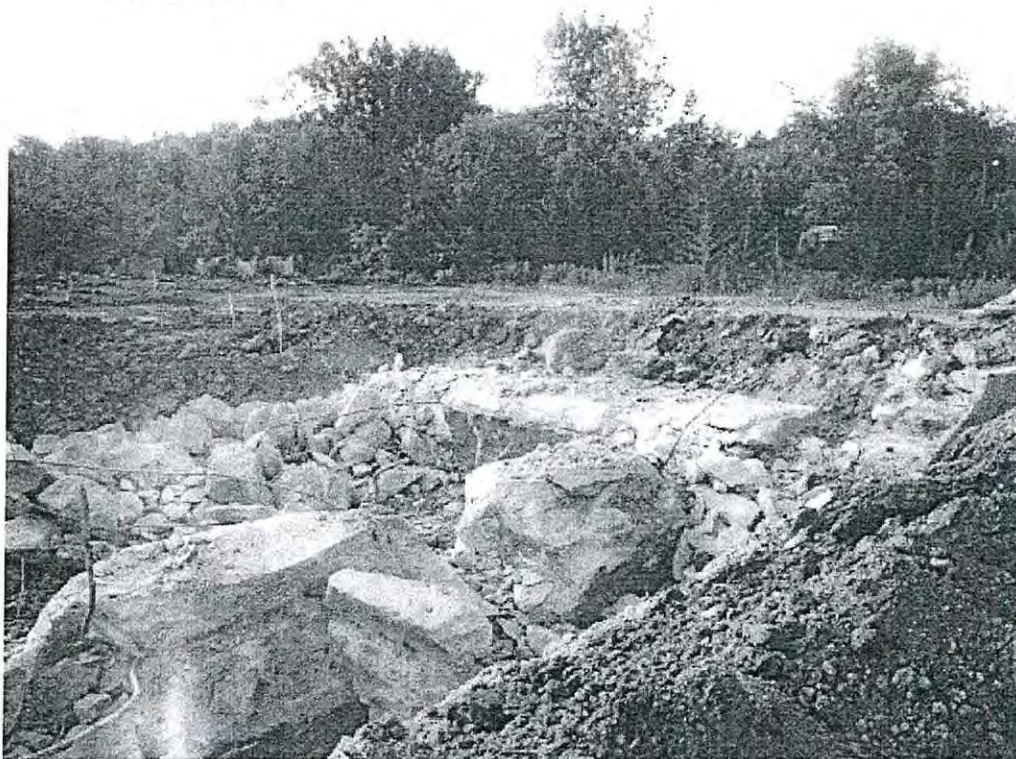
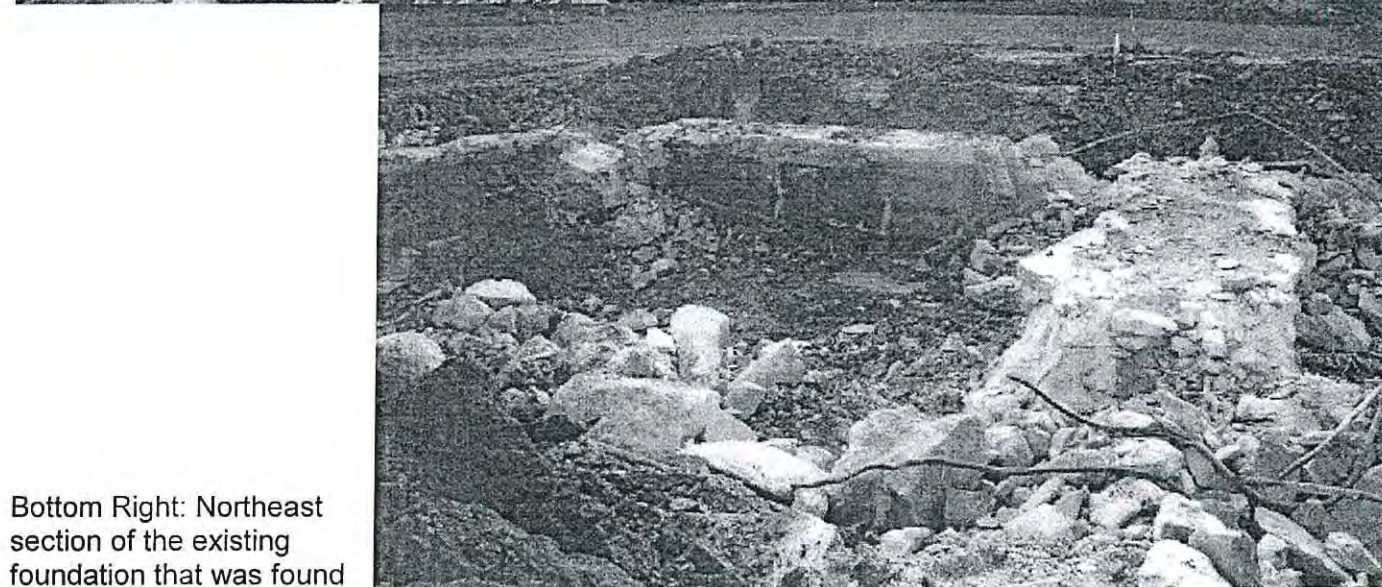
Top Left: Southeast section of the existing foundation that was found

Bottom Right: Northeast section of the existing foundation that was found

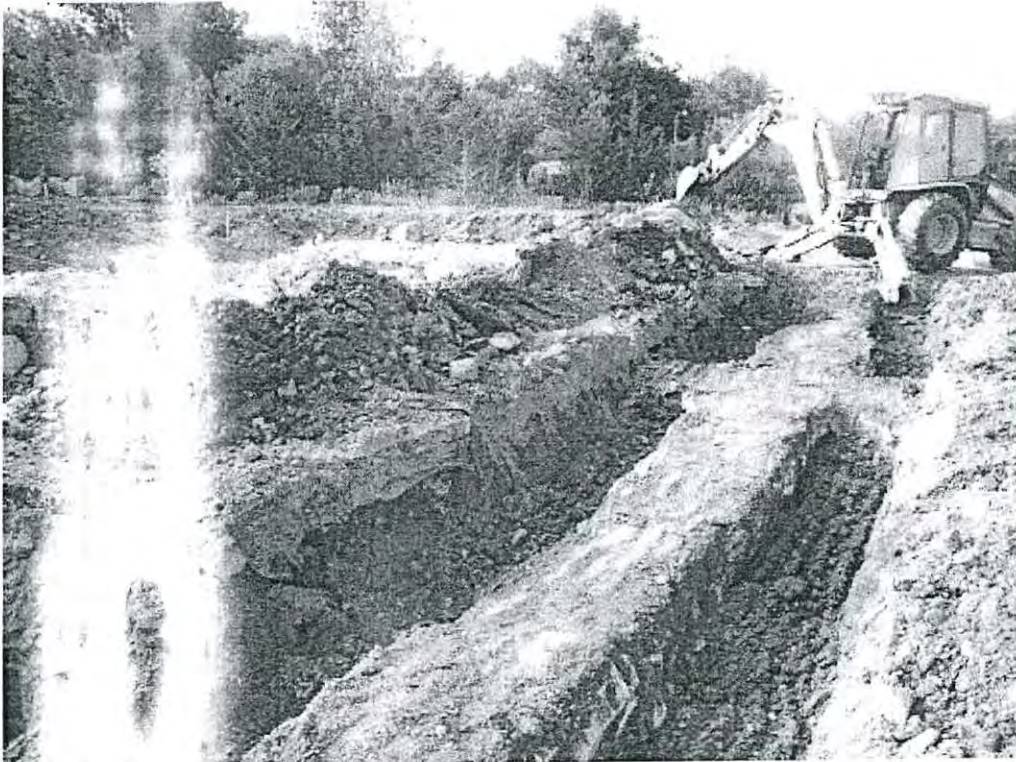
Existing excavation, looking southeast

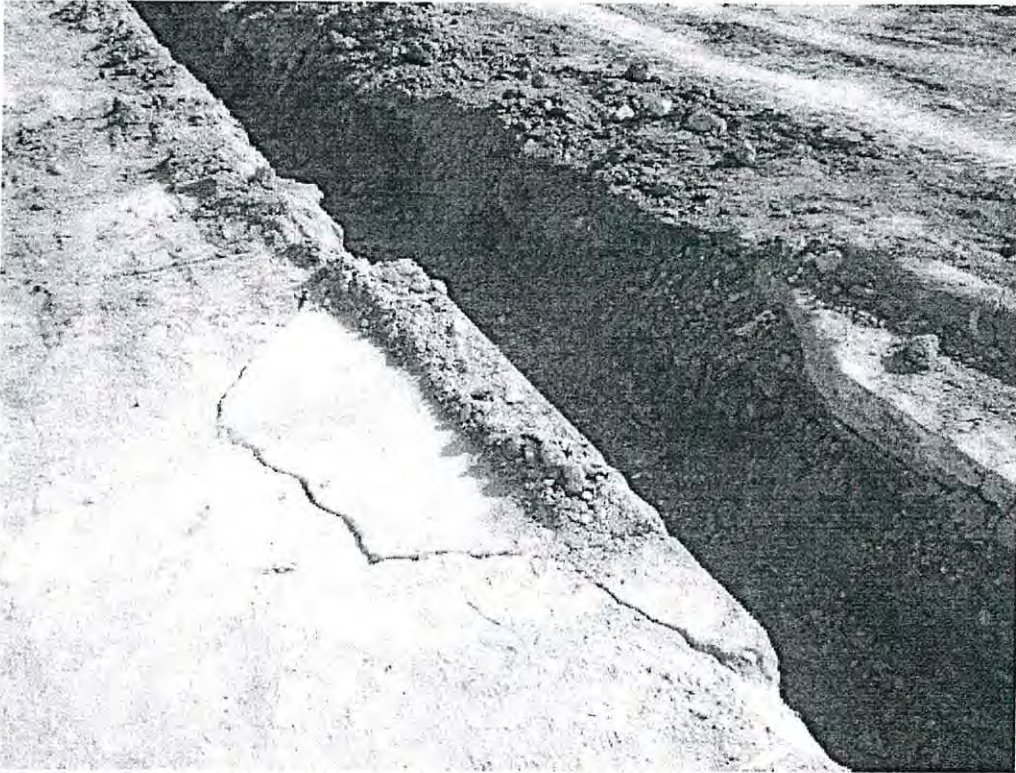
Damage to the concrete along the west side of the site, adjacent to the water line trench, damage presumably occurred during trenching, view to the north of the west side of the trench

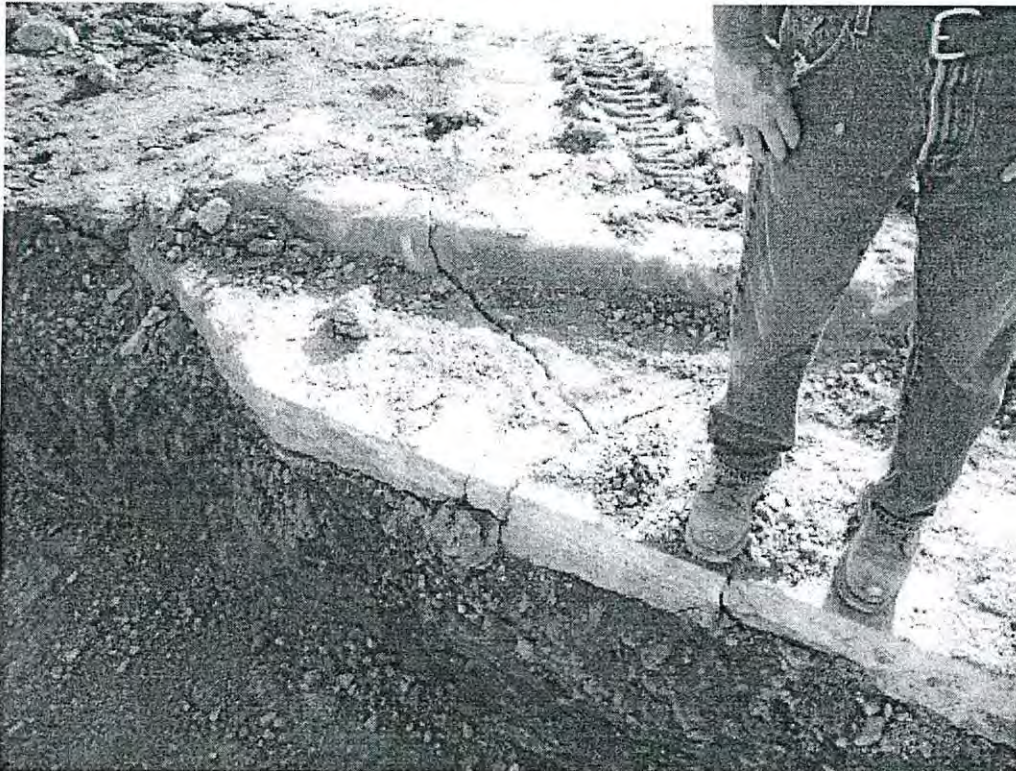
Damage to the concrete along the west side of the site, adjacent to the water line trench, damage presumably occurred during trenching, view to the east of the east side of the trench

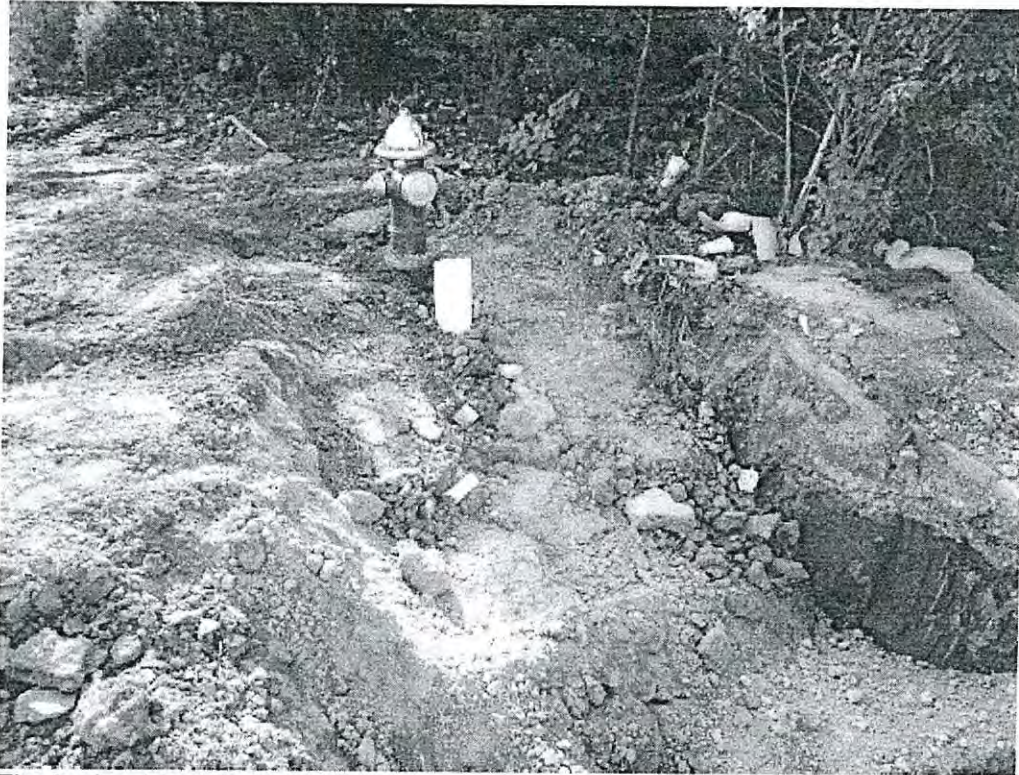
Fire hydrant installation with an incomplete valve box

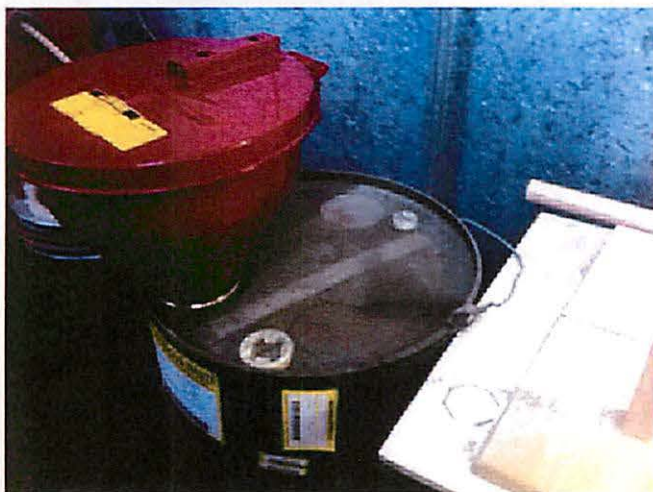
Item #7 threaded and latched funnel on hazardous waste drum.

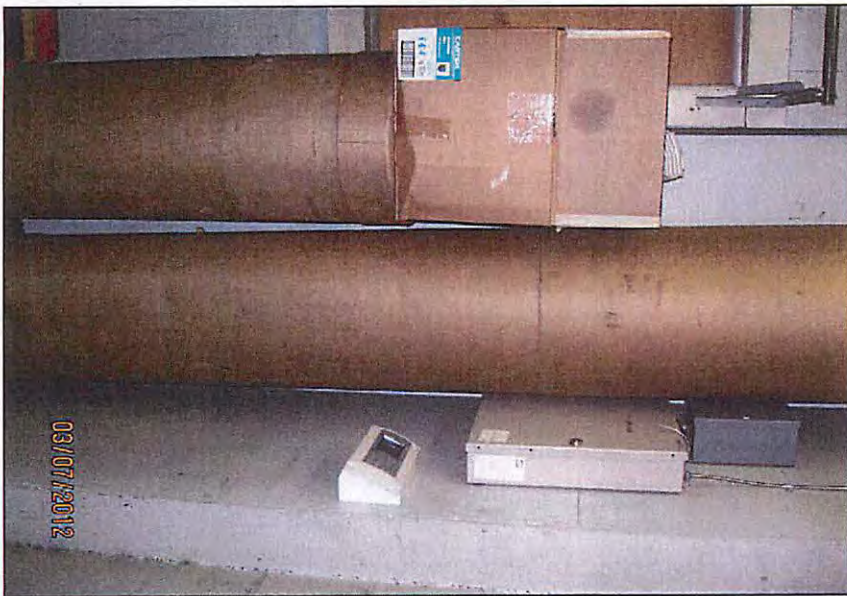
Photo No.:	1
Archive Disc File No.:	IMG_1944
Date:	March 7, 2012
Time:	3:02 AM
Location:	Near Maintenance Area
Direction Faced:	North
Weather Conditions:	Indoor
Comments:	The two left containers in the photo were not labeled with a proper universal waste label. The right container had a label on the backside, as shown in photo 2.

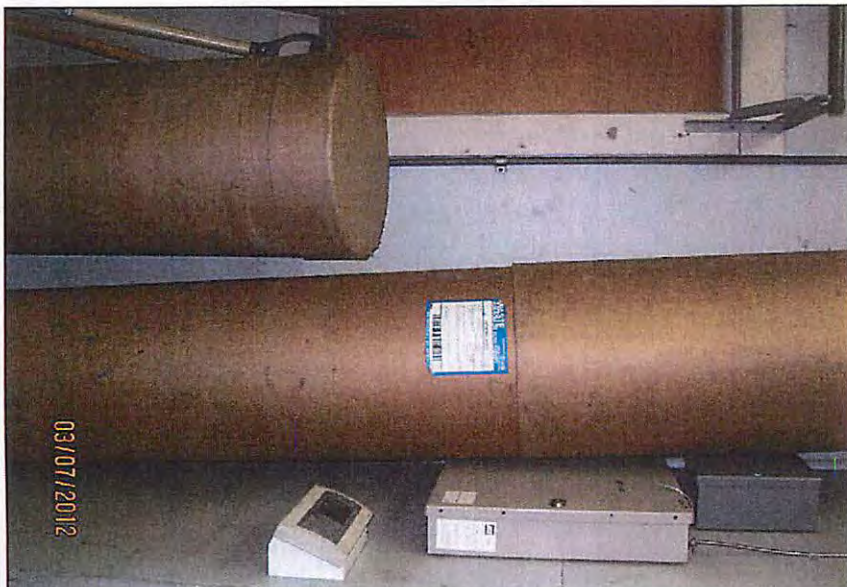
Photo No.:	2
Archive Disc File No.:	IMG_1945
Date:	March 7, 2012
Time:	3:04 AM
Location:	Near Maintenance Area
Direction Faced:	North
Weather Conditions:	Indoor
Comments:	The right container had a label on the back, which was visible when turned around.

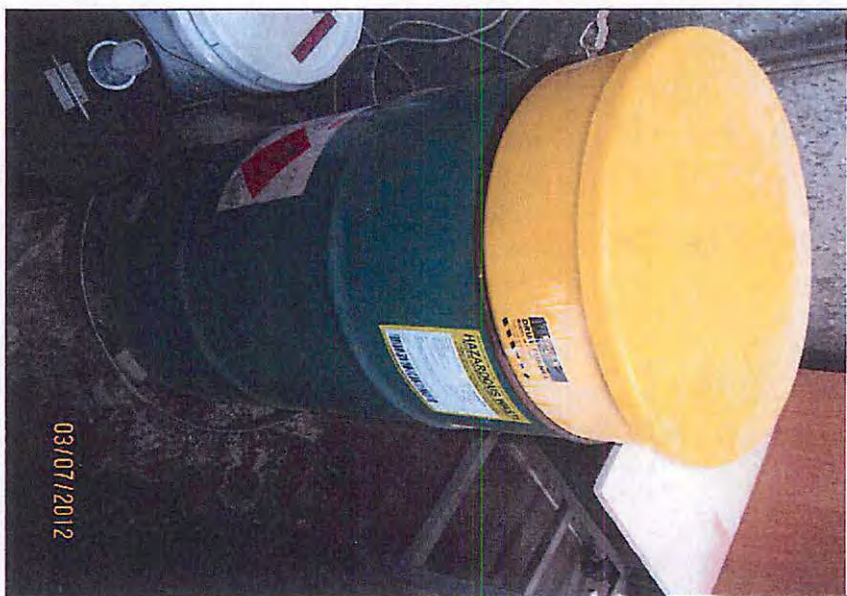
Photo No.:	<u>3</u>
Archive Disc File No.:	<u>IMG_1943</u>
Date:	<u>March 7, 2012</u>
Time:	<u>12:55 PM</u>
Location:	<u>North Paint Booth Area</u>
Direction Faced:	<u>Northwest</u>
Weather Conditions:	<u>Indoor</u>
Comments:	<u>55-gallon drum of hazardous paint related waste material with a funnel that does not attach or seal shut.</u>

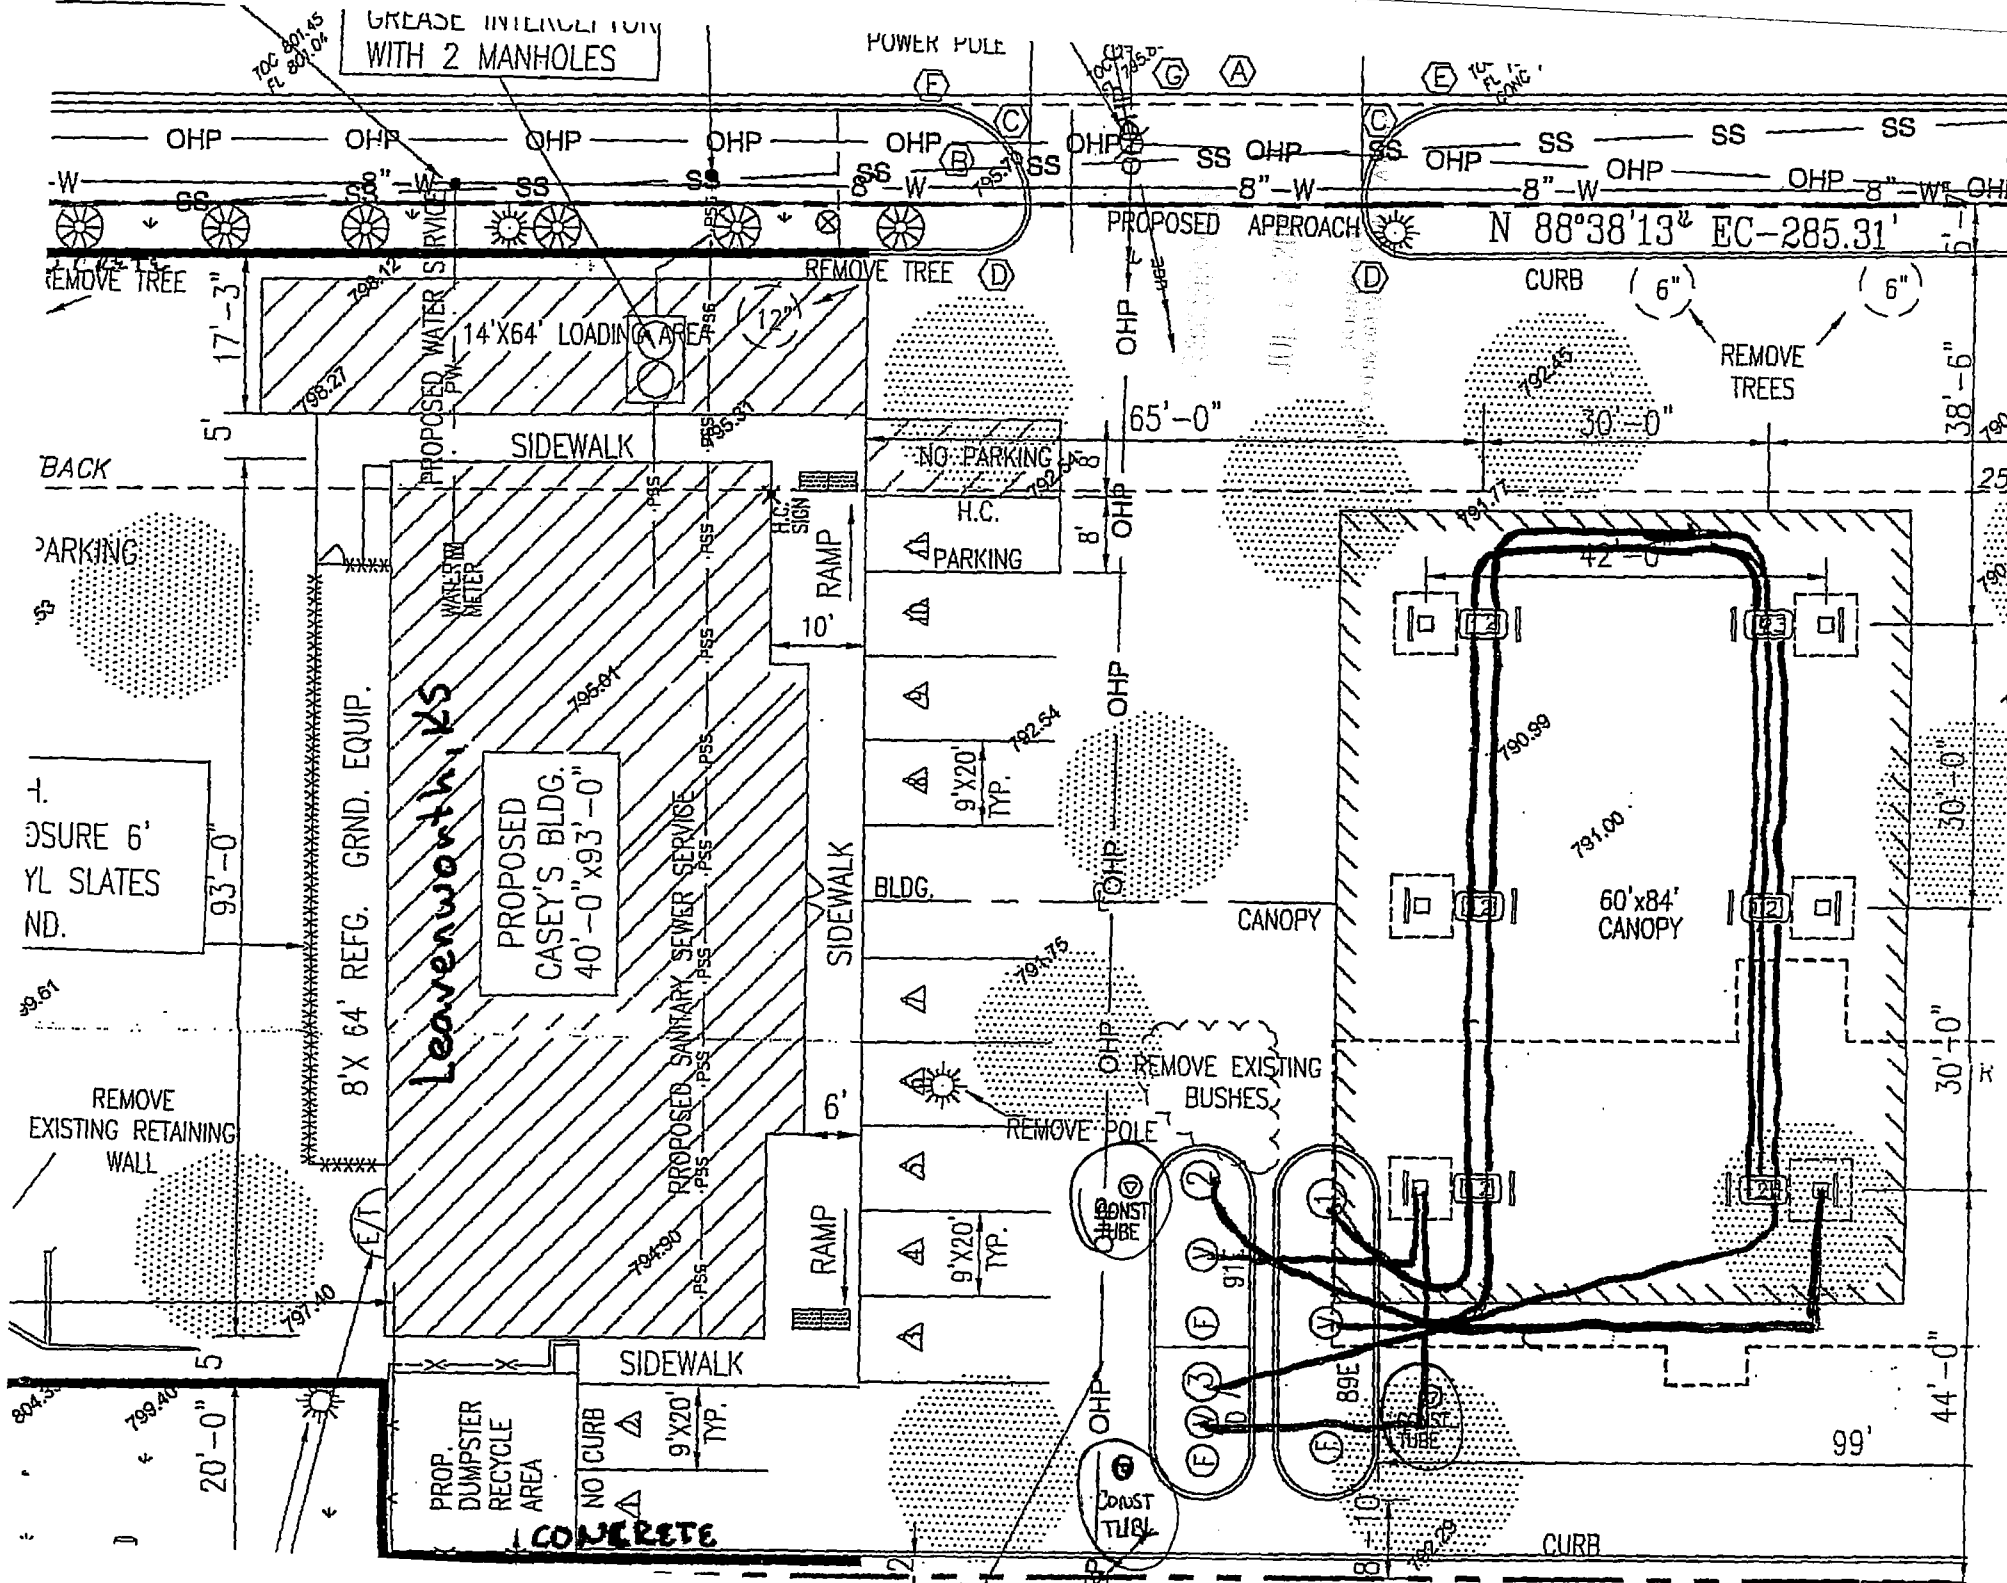
GREASE INTERCEPTOR WITH 2 MANHOLES

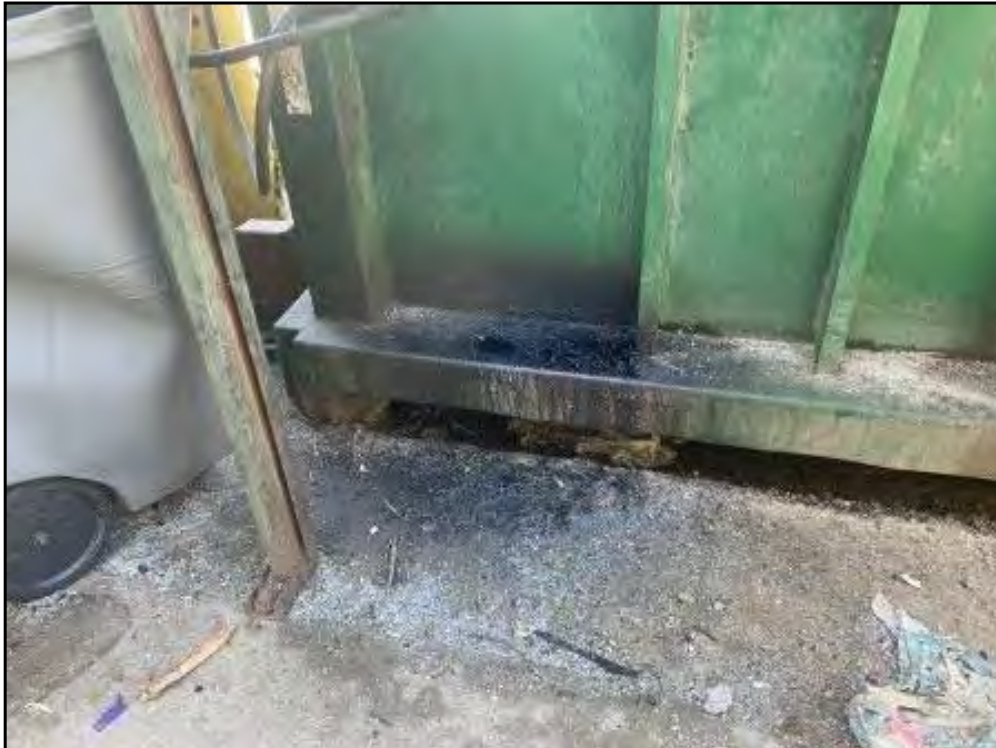
North- View of the de minimis spill observed in connection with the hydraulic trash compactor.

EWI observed a hydraulic box compactor in the back storage/stock area in the southeast corner of the structure. According to Mr. Knight, the machinery is maintained by a third party and he was not aware of any leaks or issues with the compactor. EWI also observed a trash compactor on the north side of the structure with oil staining on the equipment and asphalt beneath the compactor. The staining appeared to be minimal and no cracks in the asphalt or drains were observed in the area; on this basis, the staining is considered a de minimis condition.

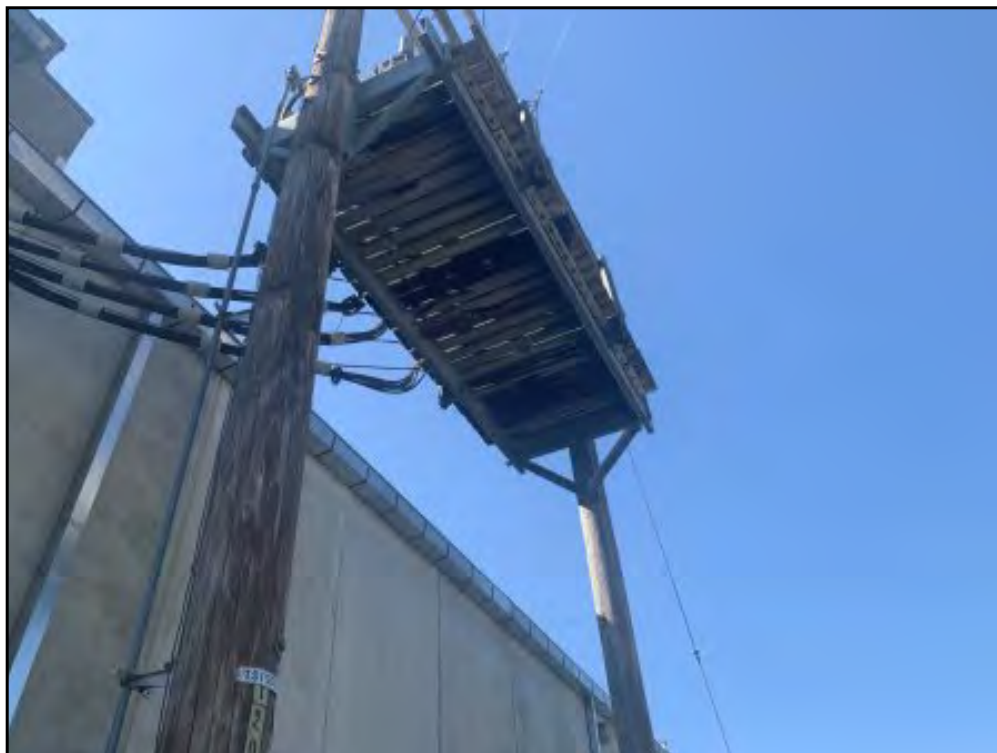
Northwest- View of the transformers located east of the structure. De minimis staining is visible on the platform beneath.

EWI observed pole-mounted transformers throughout the Site. Three (3) pole-mounted transformers were observed on the northern property boundary, one (1) pole-mounted transformer was observed in the southwest corner of the Site, and four (4) pole-mounted transformers were observed south of the Price Chopper structure. No decals were noted indicating PCB contents. No evidence of release was identified on the casings or ground beneath. In addition, EWI observed three (3) transformers on a platform east of the structure. EWI observed minor staining on the platform beneath the transformers. No evidence of release was observed on the ground beneath.
