**Independence Court Streambank Stabilization  
Feasibility Study**  
Prepared for the City of Leavenworth  
Feb. 00, 2019

Subject: Independence Court Streambank Stabilization Feasibility Study report

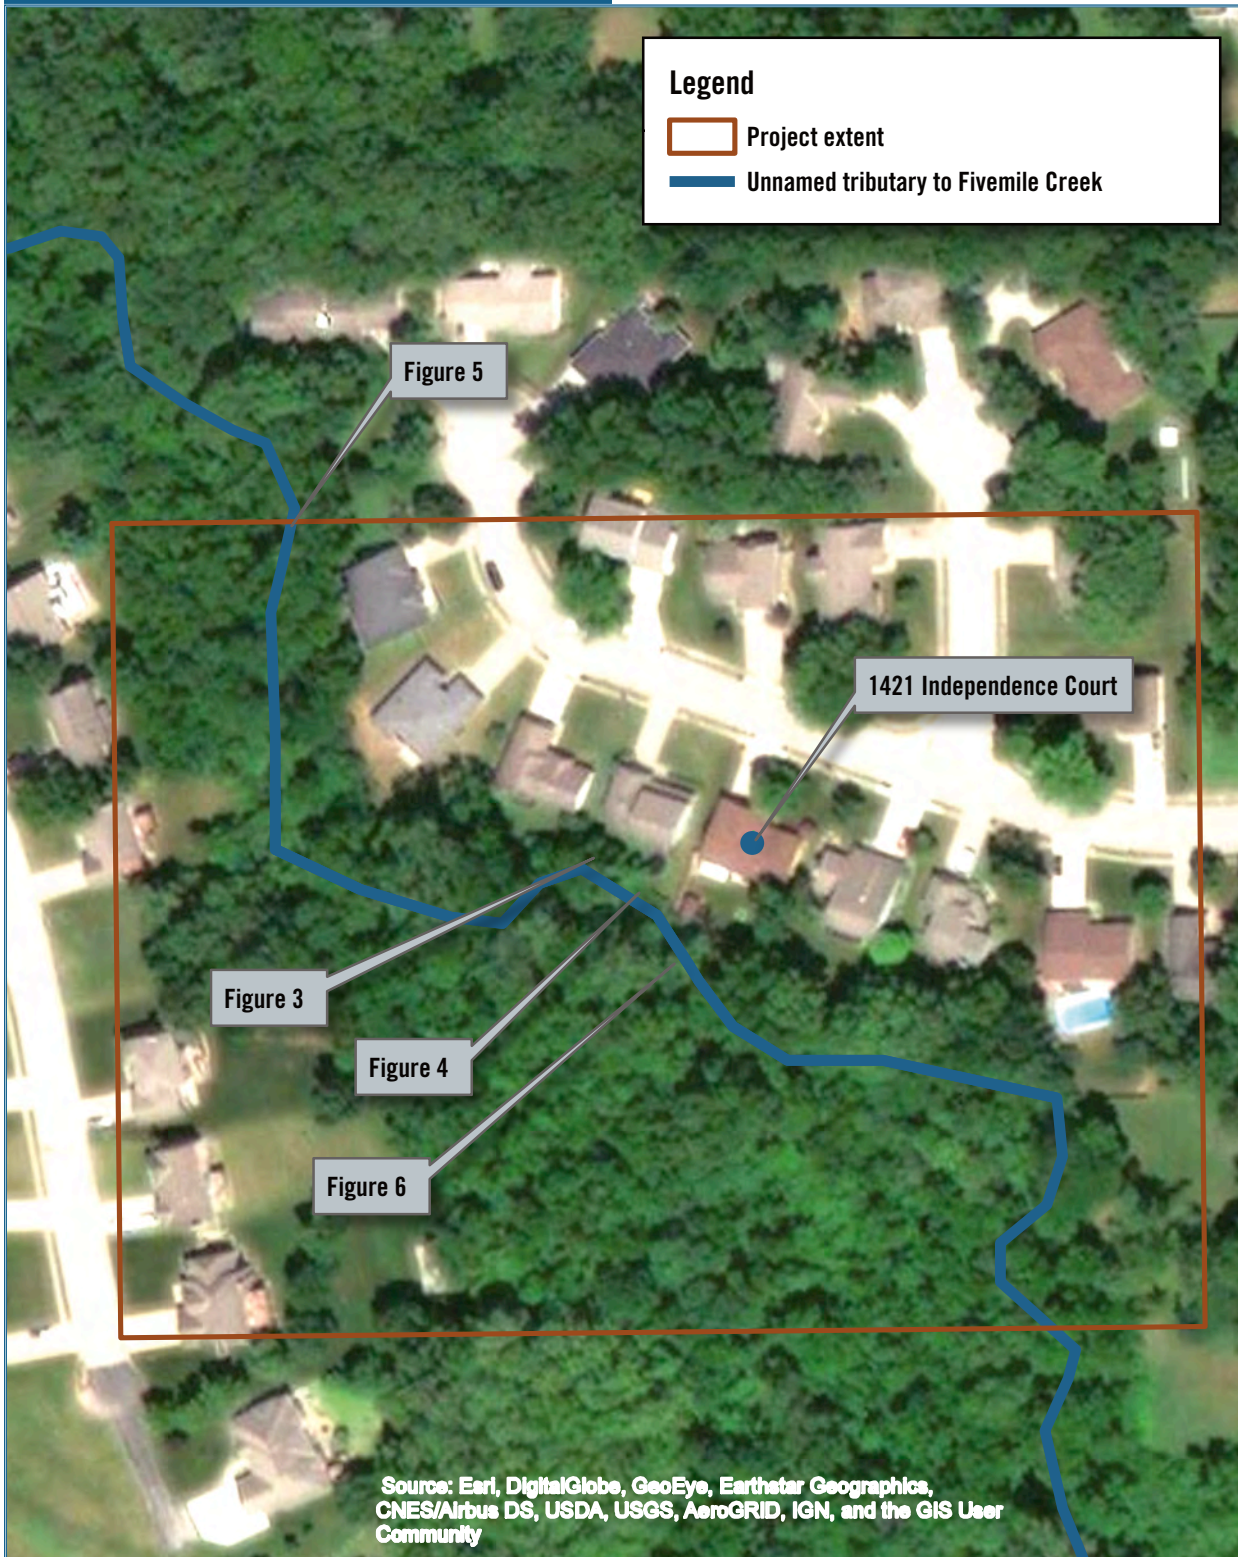
Figure 2. Project area map

Figures 3 through 6 illustrate typical examples of these issues in Reach 6. Figure 2 maps the location of the figures.

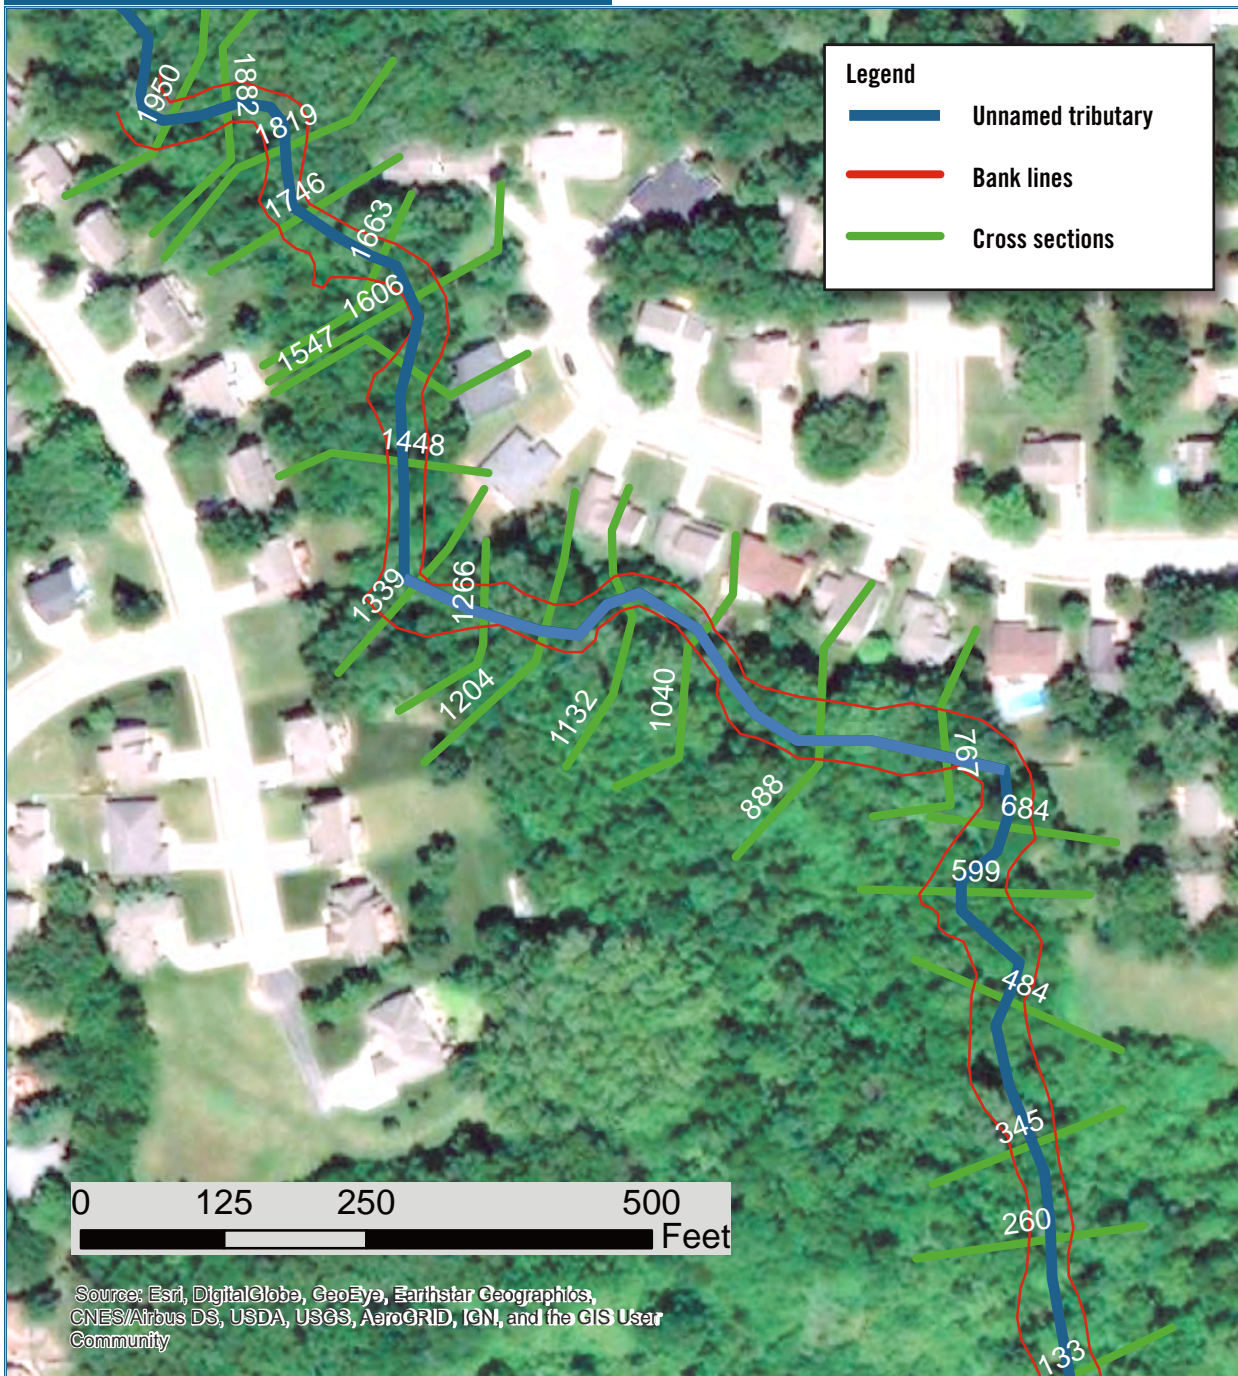
**Figure 7. Stream Reach 6 cross sections**

to the 1421 Independence Court bank failure, are detailed in Table 2. The model shows that during the 1-year and 2-year storms, a high velocity and shear stress is scouring

the left bank at the river stations shown in Table 3. The results of the analysis show that the stream condition is poor and unstable. The velocity of stream forming condi-

tion showed to be around the 1- to 2-year flow. The velocity was 6.00 to 6.56 feet per second. The shear stresses the stream experiences are 0.81 and 0.94 pounds per square

foot. Because of the type of soil and constant wetting of the toe of the embankment, mass wasting has taken place along the backs of these properties. Additionally, the city indicated that the channel may have been re-directed because of debris load at some time in its history. Based on historic aerial photos from 1947 to present, it appears the stream meander has increased in amplitude in Reach 6 and, as a result, is threatening the backs of the properties along Independence Court.

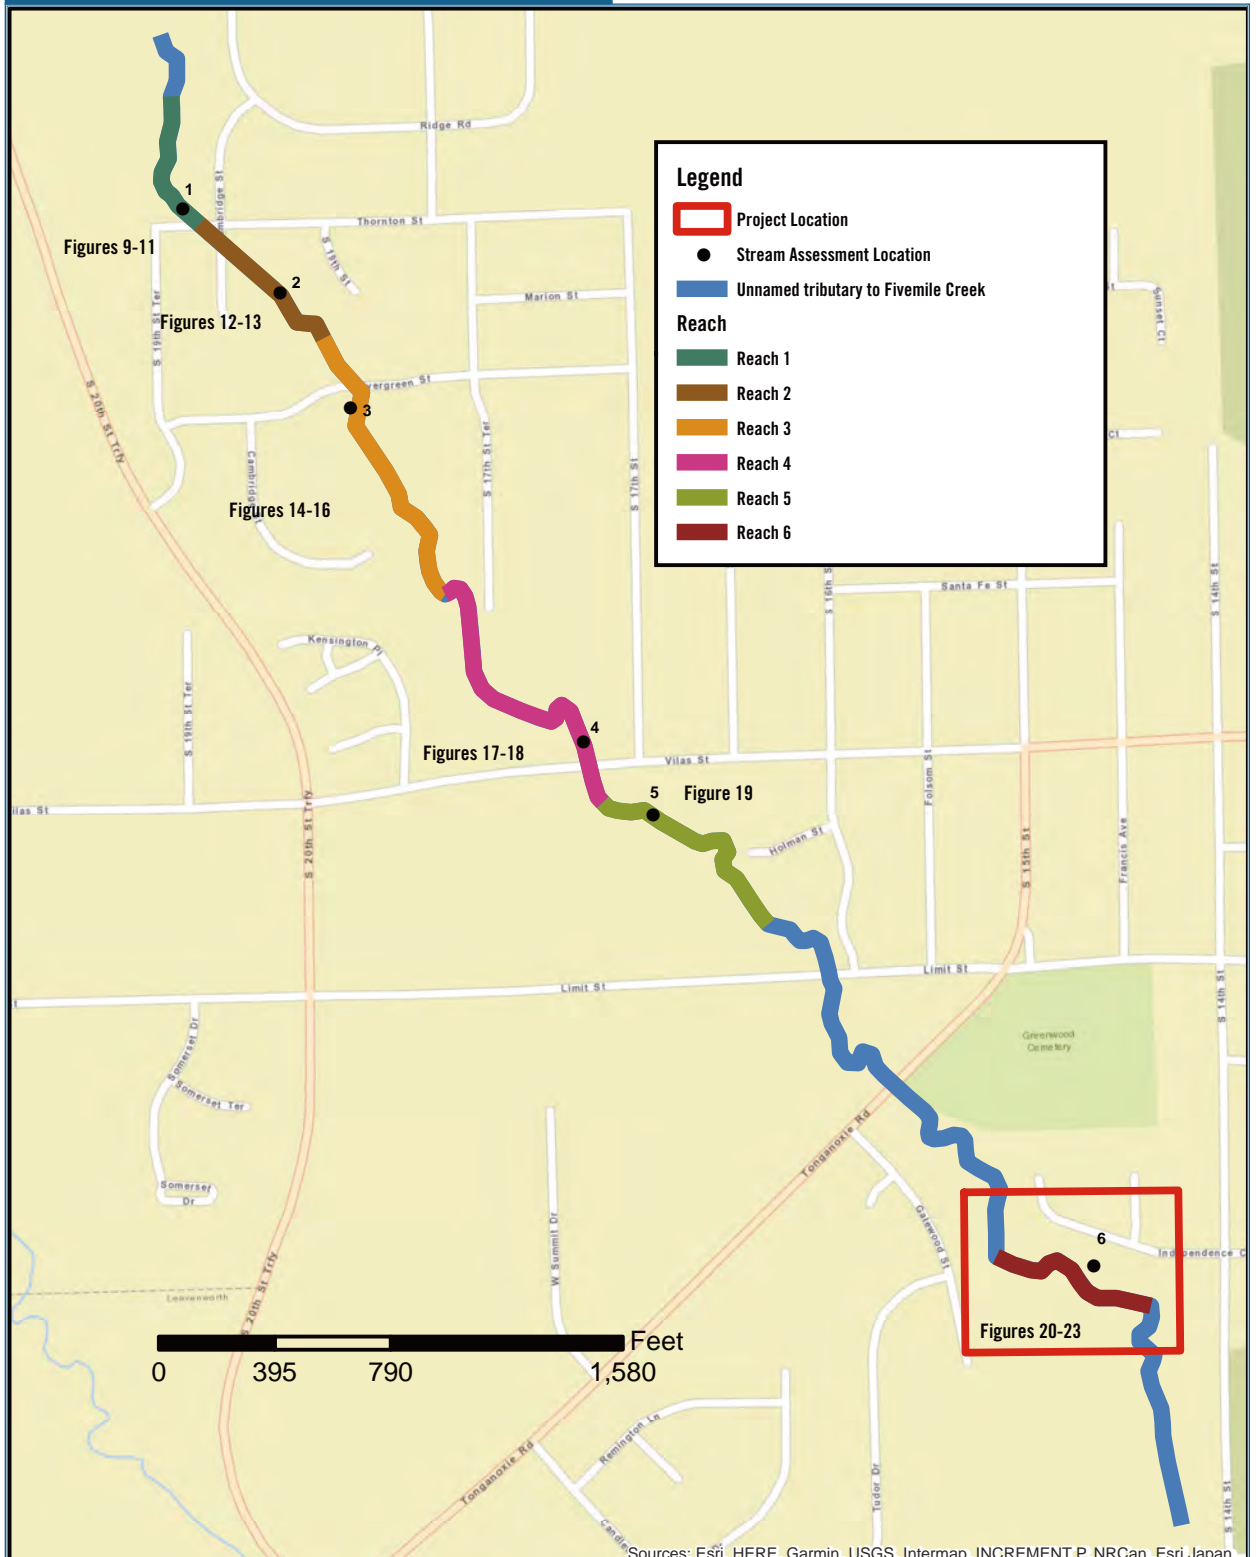
Figure 8. Stream reaches map

The stability indicator ratings are then added together to produce a total ranking. As a result, the upper limit of total ranking for a stream reach to be ranked “good” would be 9.8 (1 x 9.8). The upper limit for a stream reach to be ranked “fair” is 19.6 (2 x 9.8). Similarly, the upper limit of the total ranking for a stream reach to be ranked “poor” is 29.4 (3 x 9.8). Figure 8 illustrates the location for each of the rated stream reaches.

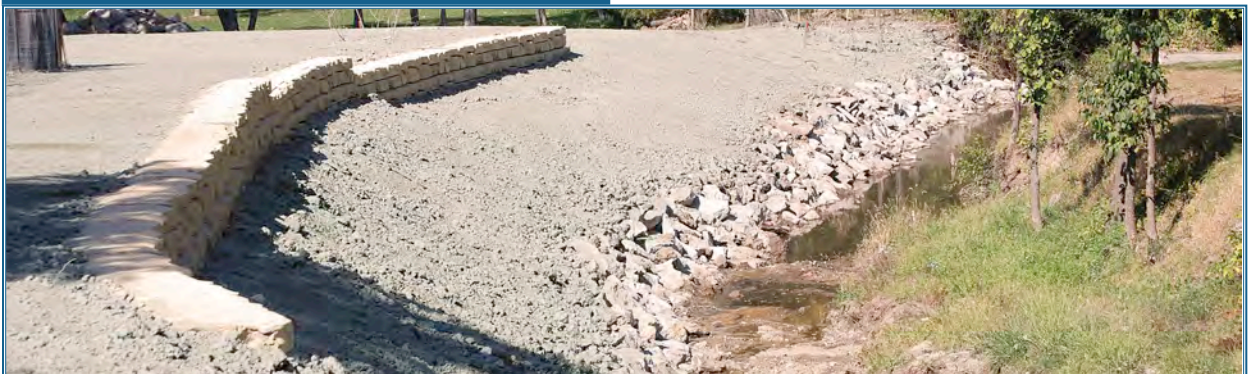
**Figure 24. Peaked stone toe protection example**

LPSTP has been successfully used to control bank failure in the past at Threemile Creek in 2017 (Figure 24).
